**Sampling Plan for Event 1B  
for the Commencement Bay Nearshore/Tideflats Superfund Site -  
Hylebos Waterway Problem Areas**

**Final Report**

July 7, 1994

Striplin Environmental Associates, Inc.

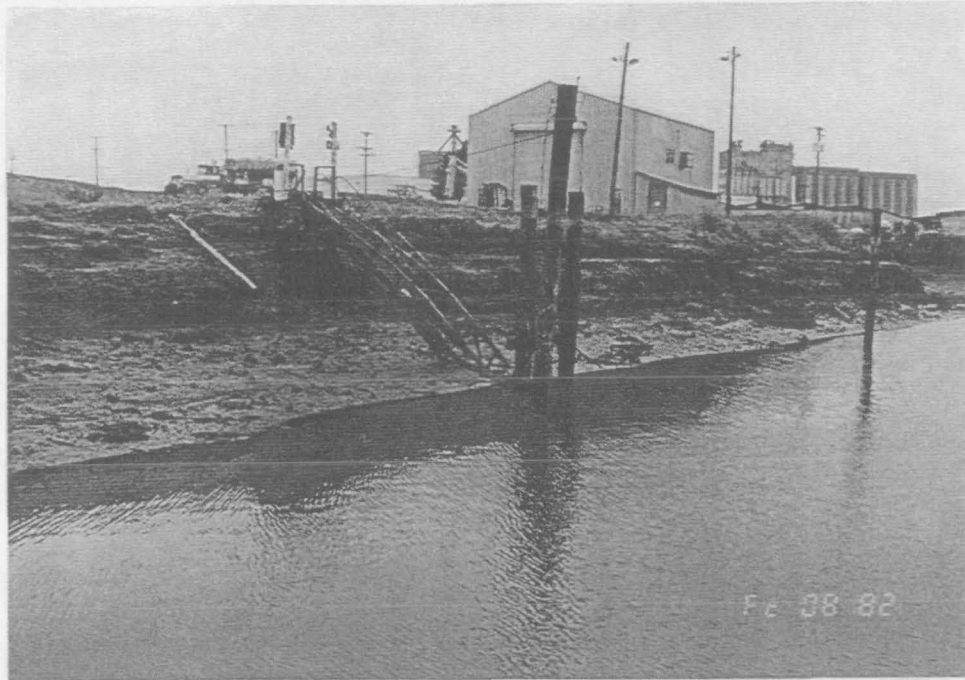
Plate 32

Photo was taken at an estimated tidal height of -0.4 foot

The sampling area is located on the western portion of the property. The length of the composite area is approximately 380 feet. There are two TPCHD listed drain pipes adjacent to the composite area (TPCHD No. 65). The upper bank contains slag (used as ballast), which may be inundated at high tide. The lower bank is gravelly with clay and cobble. Based on available studies, problem chemicals which are suspected to be associated with this portion of the site include: arsenic, copper, lead, and zinc (Tetra Tech 1985). A portion of the upland area adjacent to the sampling area was used by Seaport Bark and Supply Co. to reclaim beauty bark from log sort yard debris.

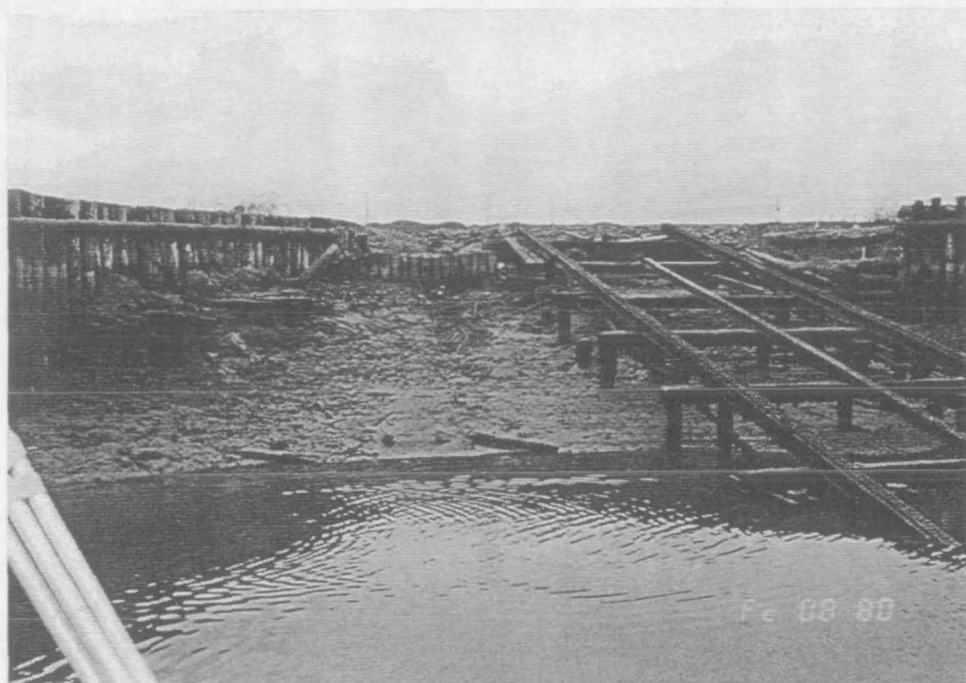
Photo was taken at an estimated tidal height of -0.1 foot

The sampling area is located at the log ramp in the middle of the property. The length of the composite area is approximately 100 feet. The upper bank consists of a decaying wood bulkhead and the lower portion appears to be compact clay. Based on available studies, problem chemicals which are suspected to be associated with this portion of the site include: arsenic, copper, lead, and zinc (Tetra Tech 1985). A portion of the upland area adjacent to the sampling area was used by Seaport Bark and Supply Co. to reclaim beauty bark from log sort yard debris.

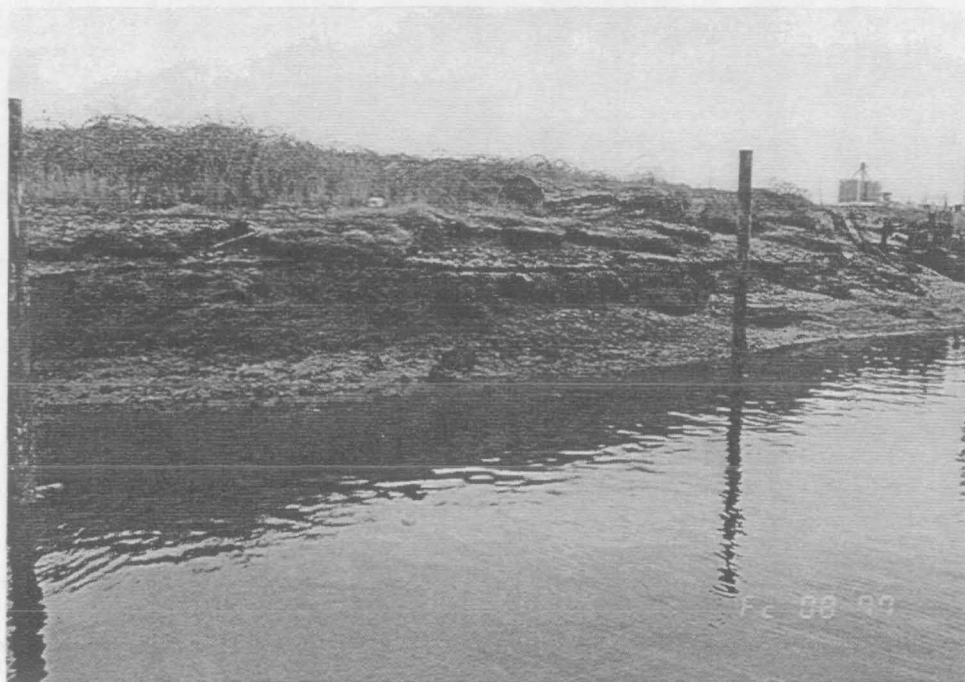
Photo was taken at an estimated tidal height of 0.1 foot

The sampling area is located at the east end of the property. The length of the composite area is approximately 375 feet. There is one listed outfall pipe in the composite area (TPCHD No. 63). The upper bank consists of fill overlying native clay. The low intertidal contains some broken pier supports and log debris. Based on available studies, problem chemicals which are suspected to be associated with this portion of the site include: arsenic, copper, lead, and zinc (Tetra Tech 1985). A portion of the upland area adjacent to the sampling area was used by Seaport Bark and Supply Co. to reclaim beauty bark from log sort yard debris.

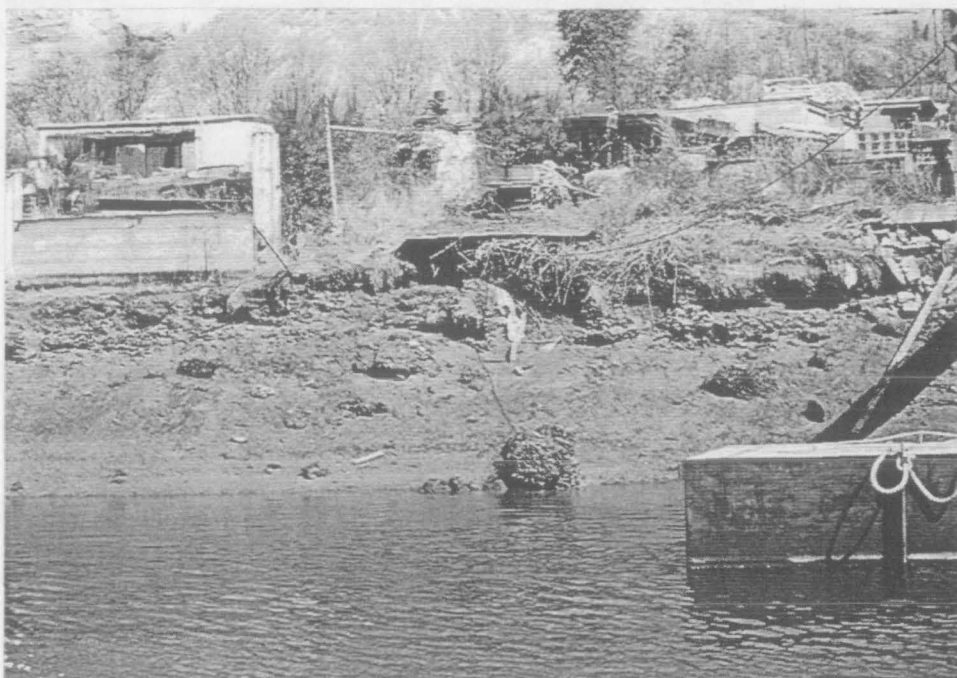
Photo was taken at an estimated tidal height of -0.1 foot

The sampling area runs the length of the shore behind the boat houses of the Hylebos Marina. The length of the composite area is approximately 690 feet. The marina has a small boat NPDES permit that requires boat wash water be recycled. The bank is short but steep and rip rapped with concrete rubble. In some places upland debris piles extend into the intertidal area. The property has been used for small boat maintenance and repair. Based on available studies, problem chemicals which are suspected to be associated with this portion of the site include copper and zinc which are associated with boat washing activities (Mercuri 1992a, Ecology 1993a).

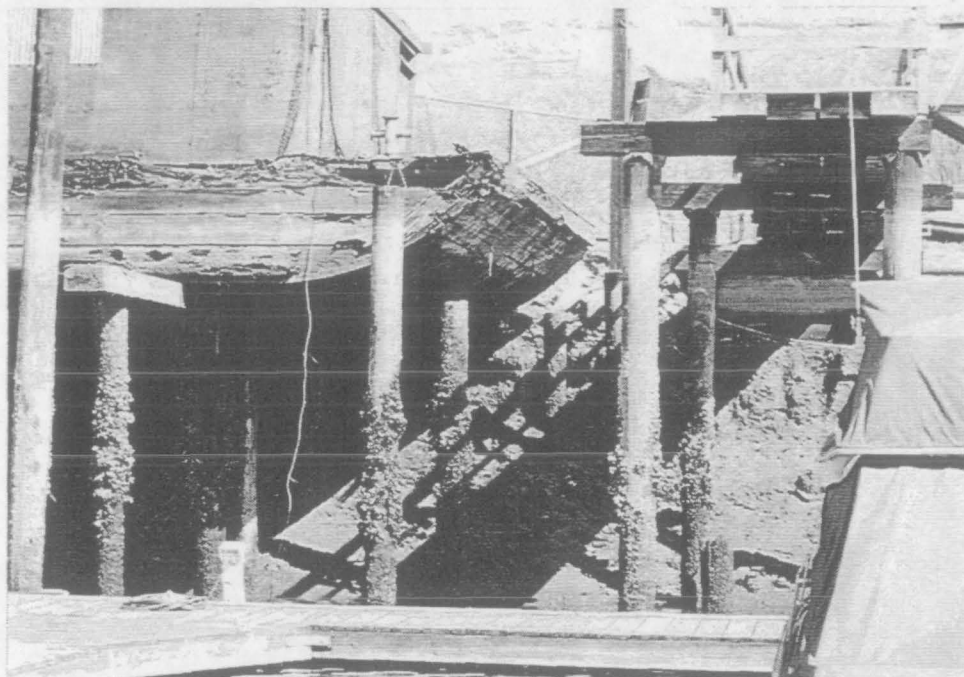
Photo was taken at an estimated tidal height of -0.5 foot

The sampling area is located at an orange colored seep on the upper bank under a barge house. There are no outfall pipes listed on the TPCHD map. The length of the composite area is approximately 25 feet. The marina has a small boat NPDES permit that requires boat wash water be recycled. The bank is vertical under the barge and consists of hard clay. The property has been used for small boat maintenance and repair. Based on available studies, problem chemicals which are suspected to be associated with this portion of the site include copper and zinc associated with boat washing activities (Mercuri 1992b, Ecology 1993a).

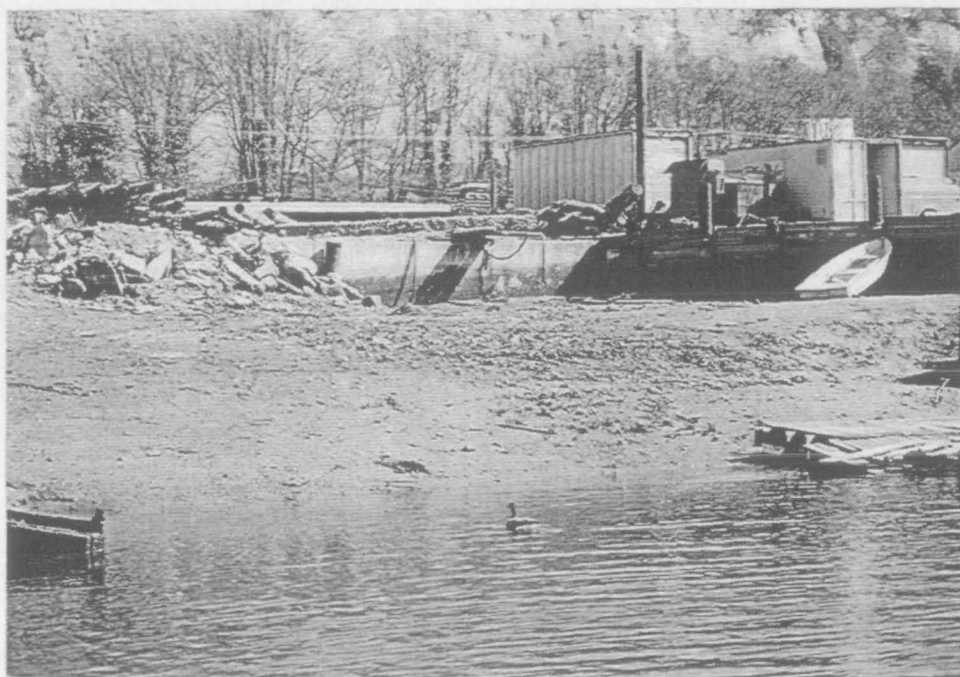
Photo was taken at an estimated tidal height of -0.3 foot

The sampling area is at the east end of the small embayment between Mather Auctioneers and the Hylebos Marina. The length of the composite area is approximately 25 feet. The bank in the sample composite area consists of a rubble pile, a concrete bulkhead and the upland area is an autofluff cleanup area (Mercuri 1993). Based on available studies, problem chemicals which are suspected to be associated with this portion of the site include: PCB's, cadmium, copper, lead, nickel, and zinc (Mercuri 1992c, 1993).

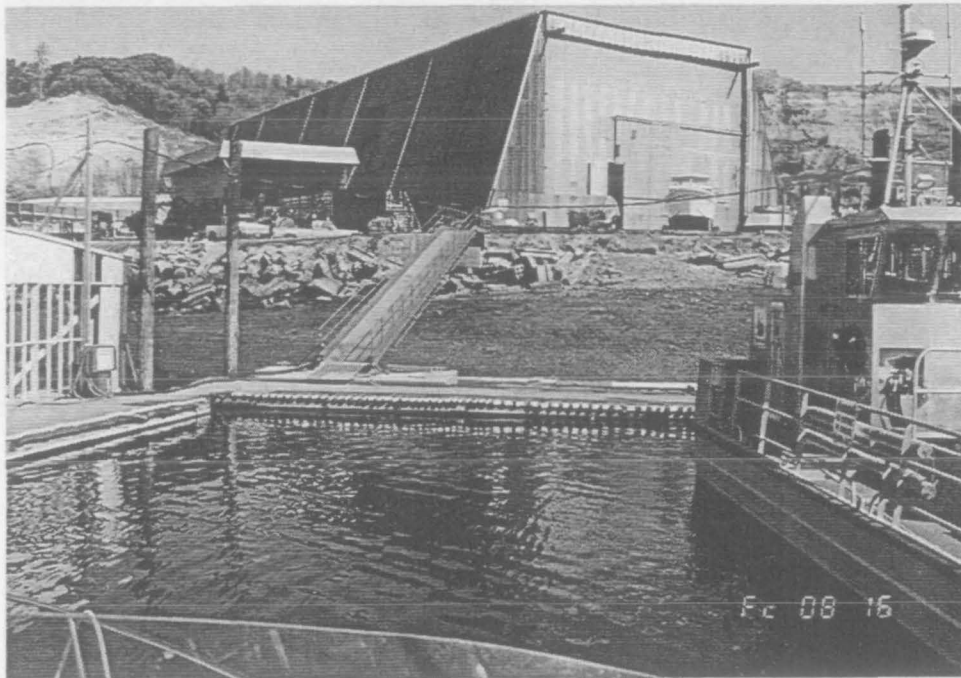
Photo was taken at an estimated tidal height of -0.3 foot

The sampling area extends across the entire shoreline in front of the property. The length of the composite area is approximately 375 feet. Stormwater runoff enters the waterway through TPCHD drain No. 23 which is located on the property between Modutech Marine and Donald Oline. Modutech Marine has a small boat NPDES permit that requires boat wash water be recycled. For the most part the upper bank is covered with concrete rubble, and sandblast grit was found in the intertidal area (Mercuri 1992). Historically, boat wash water has run into the waterway. The property has a shoreline permit to regrade the bank to a 3 to 1 slope within the next year. Based on available studies, problem chemicals which are suspected to be associated with this portion of the site include: PCB's, PAH's, copper, lead, mercury, and zinc (Mercuri 1992d).

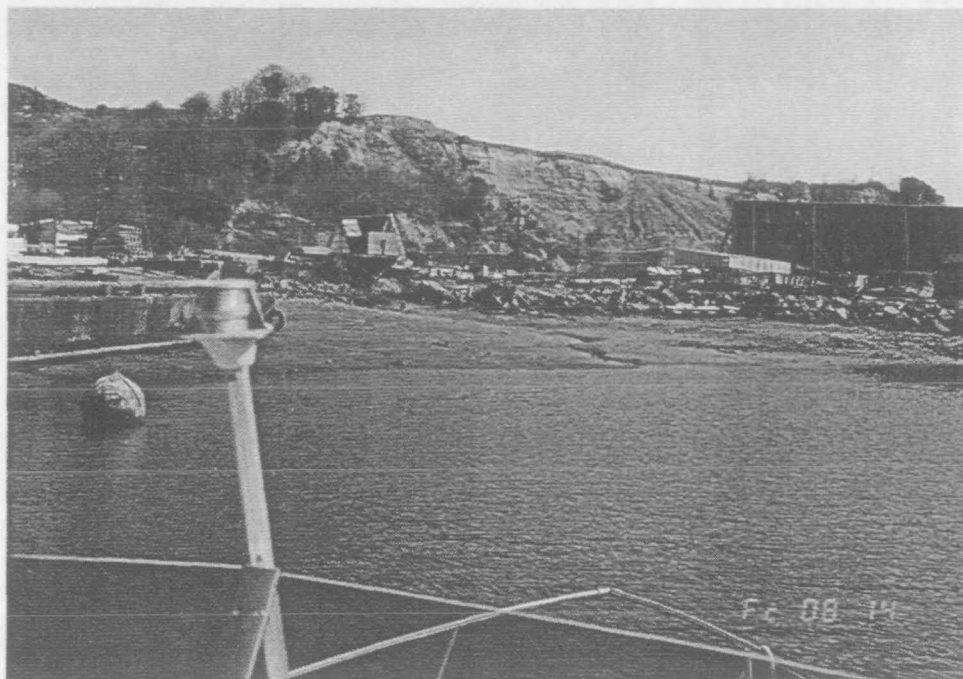
Photo was taken at an estimated tidal height of -0.3 foot

The sampling area is in the middle of the small embayment and includes a portion of both the Modutech Marine and Don Oline properties. The length of the composite area is approximately 300 feet. There are two listed outfall pipes in the sample composite area (TPCHD No. 22, 23). In addition to the outfall pipe there is a channel created by running water from a barge on the west side of the sample composite area. The bank is composed of compact clay with debris covering most of the upper area. The lower bank consists of a small mud flat. Based on available studies, problem chemicals which are suspected to be associated with this portion of the site include: PCB's, PAH's, phenols, phthalates, cadmium, copper, lead, and zinc (Gooding 1991a).

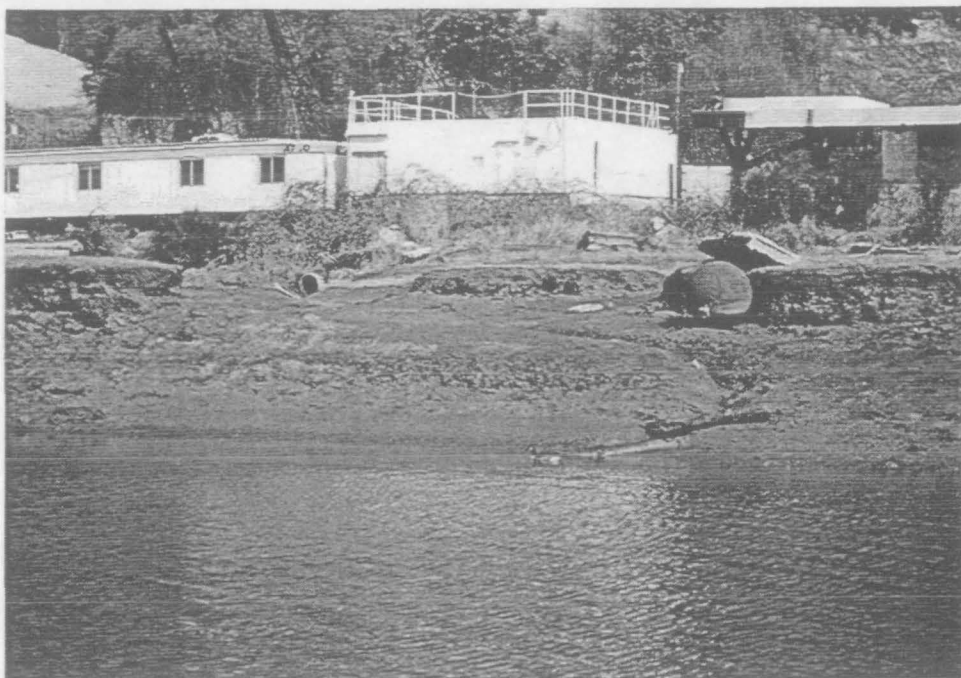
**Plate 42**

Photo was taken at an estimated tidal height of 0.0 feet

The sampling area is on the western portion of the Oline property, and encompasses two piers. The length of the composite area is approximately 350 feet. There is one listed outfall pipe in the sample composite area (TPCHD No. 21). The bank is similar in composition to that in area 3218I with much debris on the upper bank. Based on available studies, problem chemicals which are suspected to be associated with this portion of the site include: PCB's, PAH's, phenols, phthalates, cadmium, copper, lead, and zinc (Ecology 1993a).

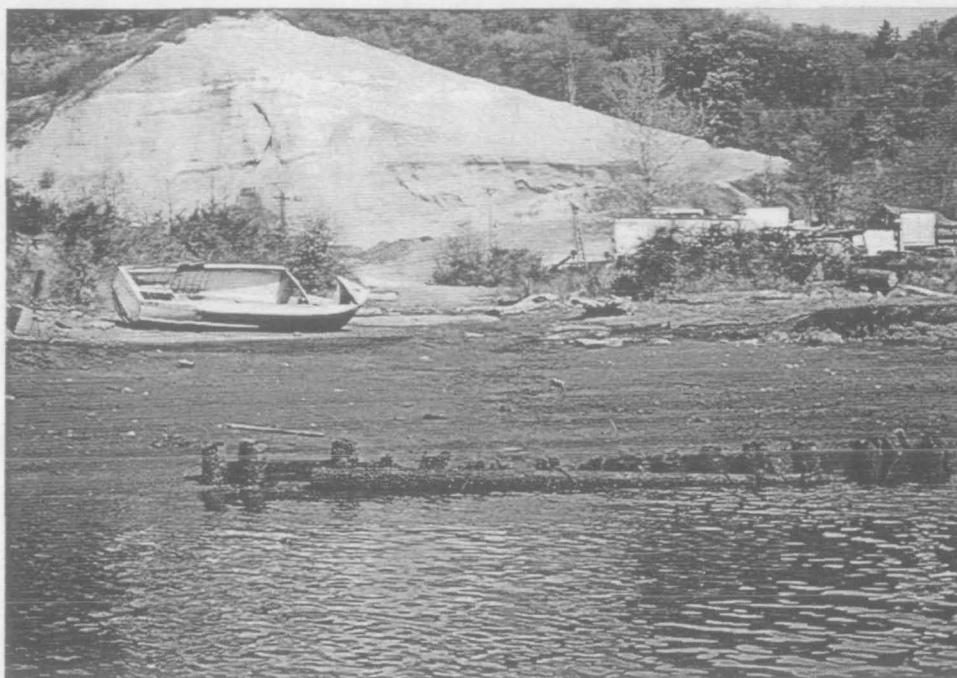
Photo was taken at an estimated tidal height of 0.1 foot

The sampling area is located on the eastern portion of the property and includes a small embayment. The length of the composite area is approximately 400 feet. The property contains one listed outfall pipe (TPCHD No. 20). Wood waste and slag is present in the bank (Mercuri 1994). The upland area is scheduled to be cleaned up during the spring/summer 1994 under a consent decree from Ecology (Mercuri 1994). Slag contamination will be removed only to the top of the bank and not into the intertidal area (Mercuri 1994). Based on available studies, problem chemicals which are suspected to be associated with this portion of the site include: arsenic, copper, lead, and zinc (Norton and Johnson 1988, Applied Geotechnology 1988).

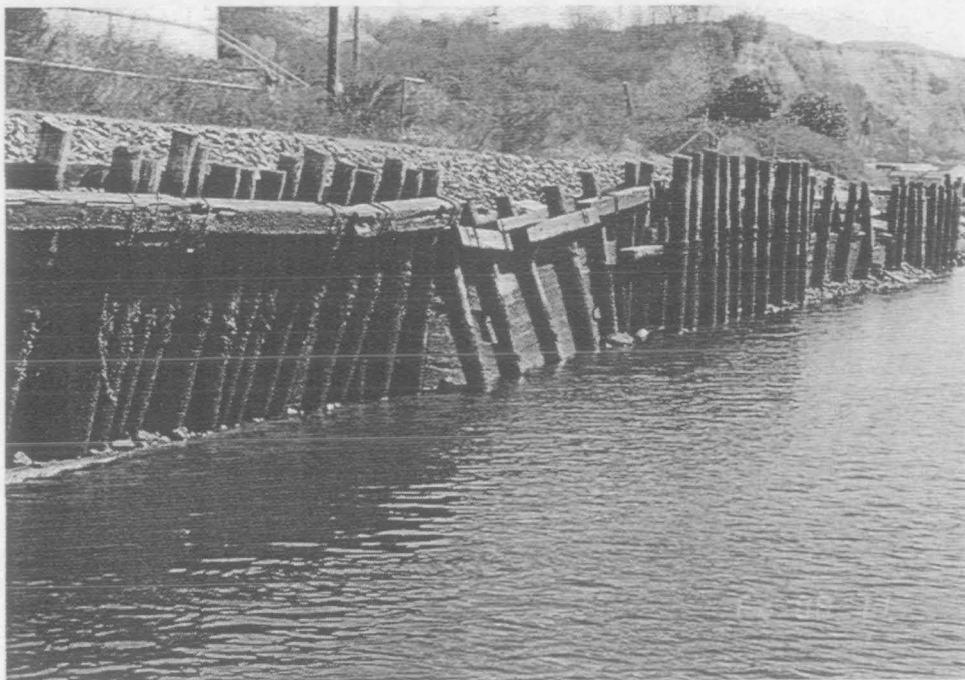
**Sample Area 3221I****Sound Refining Inc.****Plate 45**

Photo was taken at an estimated tidal height of 0.2 foot

The sampling area is located at the eastern end of the Sound Refining property. The length of the composite area is approximately 430 feet. There are two listed outfall pipes in the sample composite area (TPCHD No. 18 and 19). Sound Refining Inc. has an Individual NPDES permit to discharge treated process wastewater and stormwater into the waterway. The bank is held in place with a wood bulkhead which is back-filled with rubble. The bulkhead is sagging and breaking up in some places. Based on available studies, problem chemicals which are suspected to be associated with this portion of the site include: hexachlorobenzene, benzyl alcohol, phenol, PCB's, arsenic, copper, and zinc (Parametrix 1992).

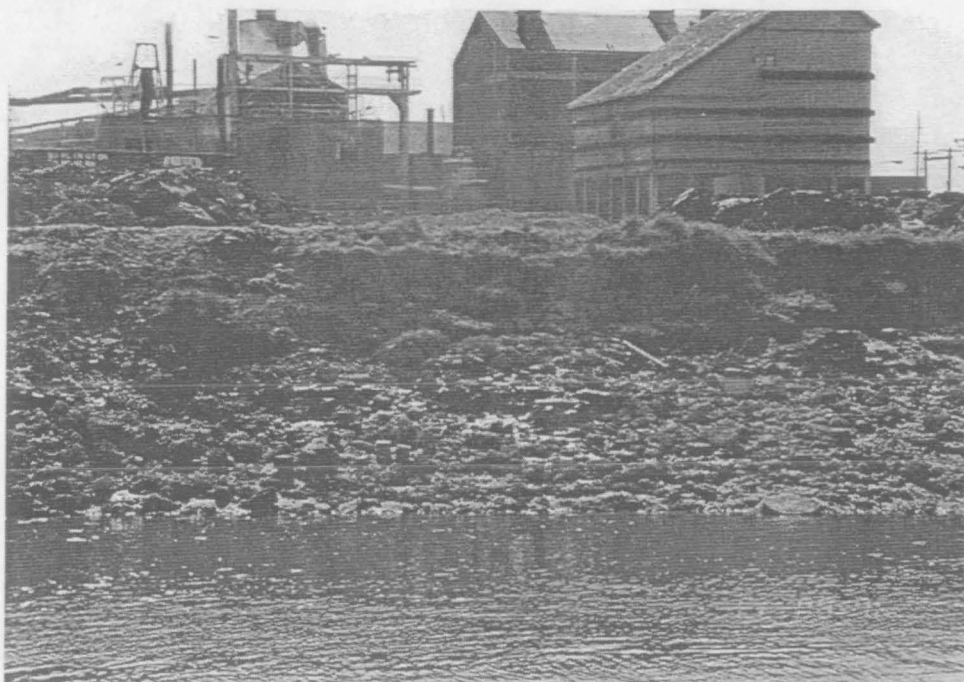
**Plate 46**

Photo was taken at an estimated tidal height of 3.0 feet

The sampling area is located across the entire shoreline. The length of the composite area is approximately 150 feet. There is one outfall pipe in the sample composite area (TPCHD No. 62). The top of the bank consists of fill and debris. Slag was used as feed material for their rock wool production process at the site, a portion of which was cleaned up in 1973 (Coleman et al. 1992, Mercuri 1994). There were steel drums and other metal debris on the top of the bank and along the shoreline. USG and Ecology signed an agreed order for a phase 1 site investigation on March 1, 1994. Based on available studies, problem chemicals which are suspected to be associated with this portion of the site include: arsenic, copper, chromium, lead, and zinc (Coleman et al. 1992, Ecology 1994).

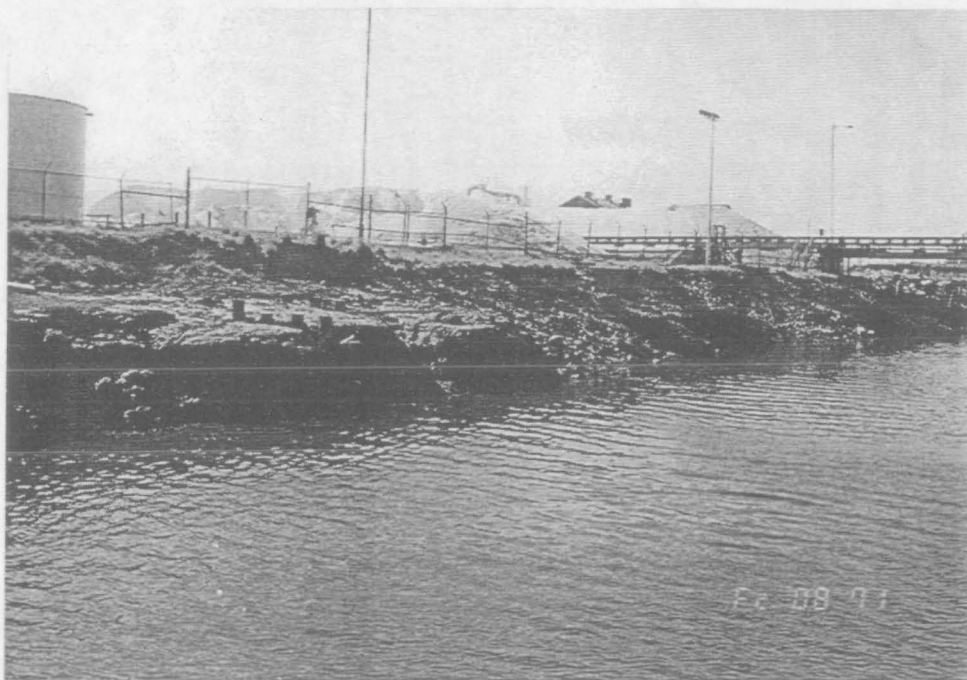
**Plate 48**

Photo was taken at an estimated tidal height of 2.2 feet

The sampling area is located along the western portion of the property. The length of the composite area is approximately 500 feet. There are two listed outfall pipes in the sample composite area (TPCHD No. 60). Elf Atochem North America has an Individual NPDES permit for the discharge of process wastewater and stormwater to the waterway. The sample composite area is inshore of the new subtidal outfall. The upper bank consists of broken terra-cotta pipe, bricks, and concrete rubble. The mid portion of the bank is clay and in some places there are piling stubs and other wood debris. Based on available studies, problem chemicals which are suspected to be associated with this portion of the site include: perchloroethylene, hexachlorobutadiene, arsenic, chromium, and copper (Tetra Tech 1985, 1988).

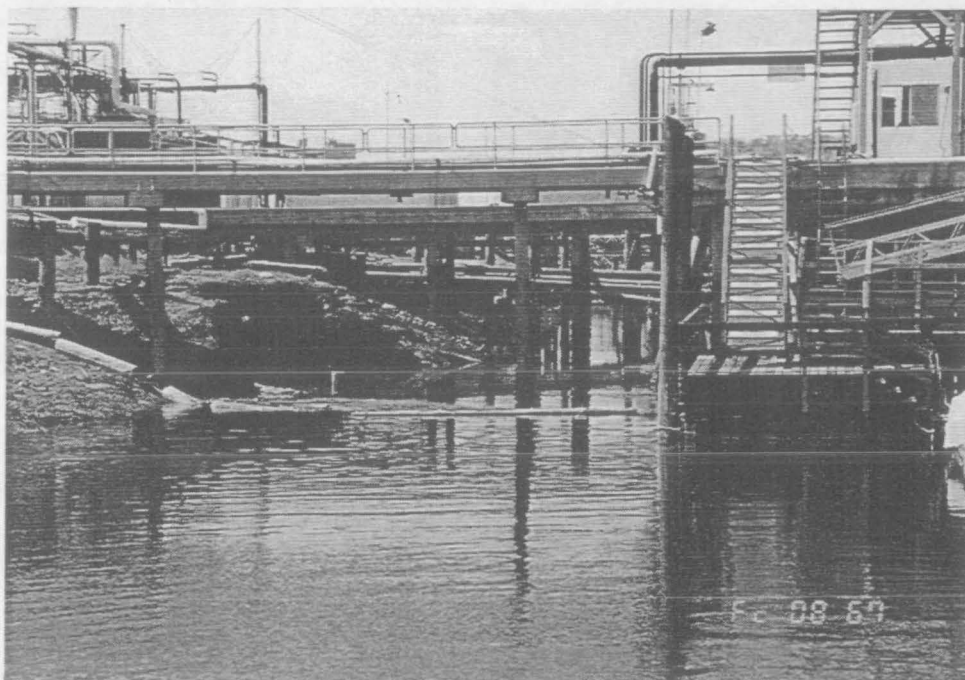
Photo was taken at an estimated tidal height of 1.8 feet

The sampling area extends across the shoreline face behind the main dock. The length of the composite area is approximately 400 feet. There are seven outfall pipes listed on the TPCHD map in the sample composite area (TPCHD No. 57, 58). Elf Atochem North America has an Individual NPDES permit for the discharge of process wastewater and stormwater to the waterway. The bank in this area is full of broken concrete rubble, bricks, and machine parts (Mercuri 1994). Reddish discolorations were noted in the seep area. Based on available studies, problem chemicals which are suspected to be associated with this portion of the site include: perchloroethylene, hexachlorobutadiene, arsenic, chromium, and copper (Tetra Tech 1985, 1988).

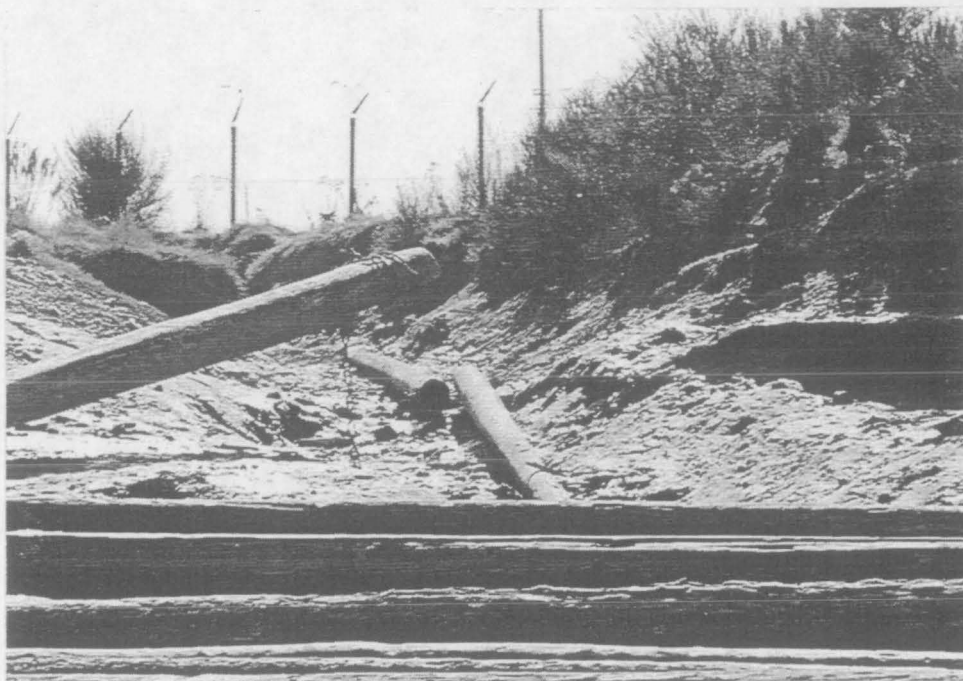
Photo was taken at an estimated tidal height of 1.5 feet

The sampling area extends a short distance to the west from the East Channel Ditch. The length of the composite area is approximately 105 feet. The Ditch is identified by the TPCHD as No. 54. Another outfall pipe listed by the TPCHD had emptied into the ditch, but was capped some time ago (TPCHD No. 55). The mud bank surrounding the mouth of the ditch appears fairly natural. Slag was removed from the top of the bank and from the upland area, but the investigation did not include the intertidal area (Mercuri 1994). Based on available studies, problem chemicals which are suspected to be associated with this portion of the site include: 4-methylphenol, phenol, antimony, arsenic, copper, lead, and zinc (Ecology 1993b). Historically, numerous industries have discharged water and/or wastewater into the ditch. These include Dunlap Towing Co. and Petroleum Reclamation Services, Inc.

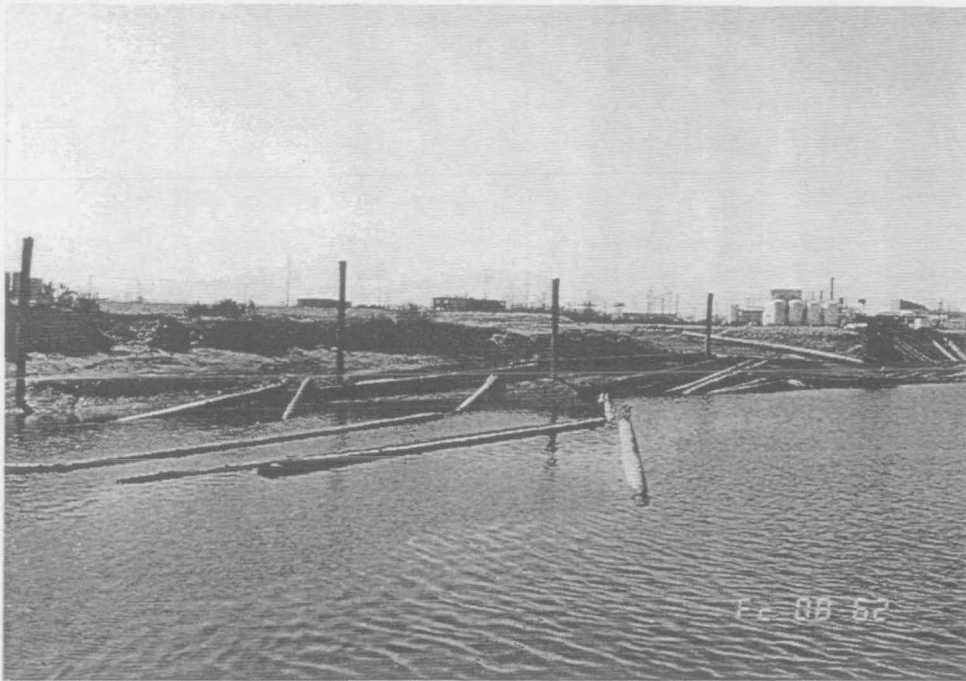
Photo was taken at an estimated tidal height of 0.9 foot

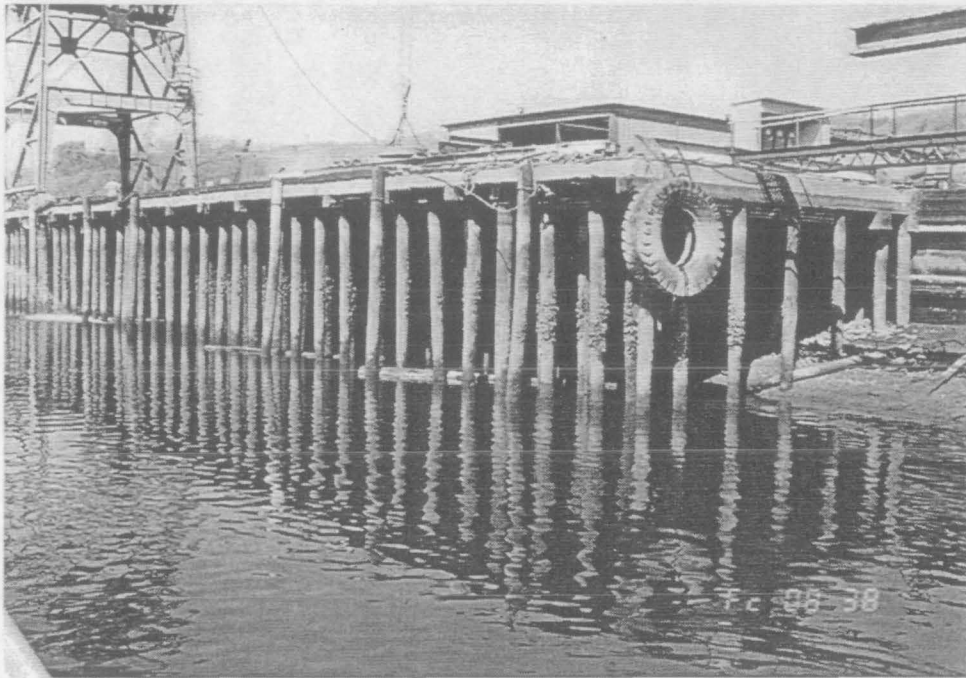
Photo was taken at an estimated tidal height of -1.2 feet

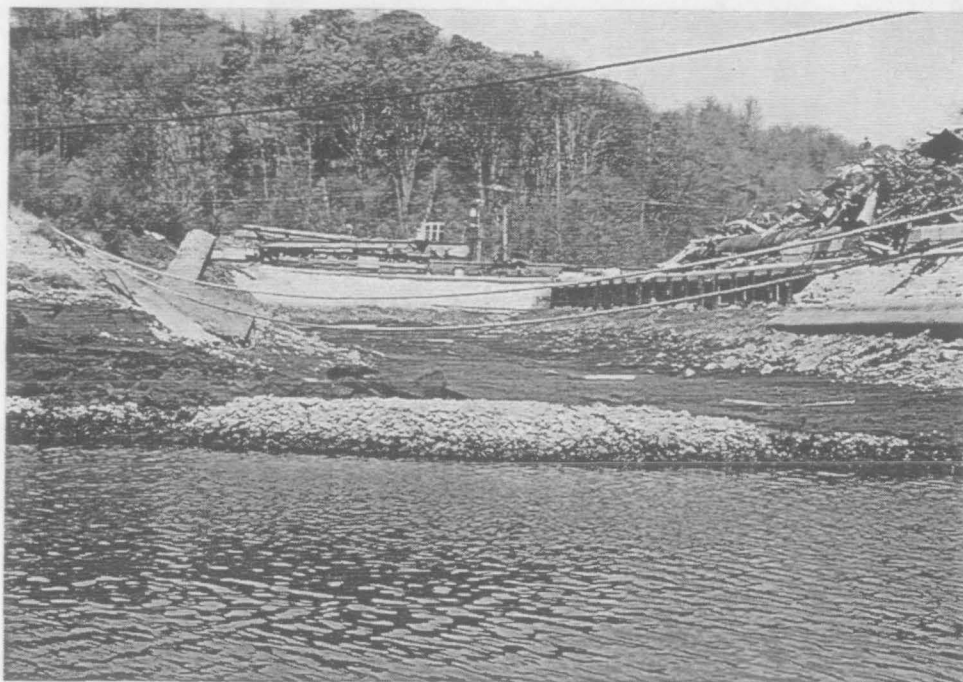
Photo was taken at an estimated tidal height of -1.2 feet

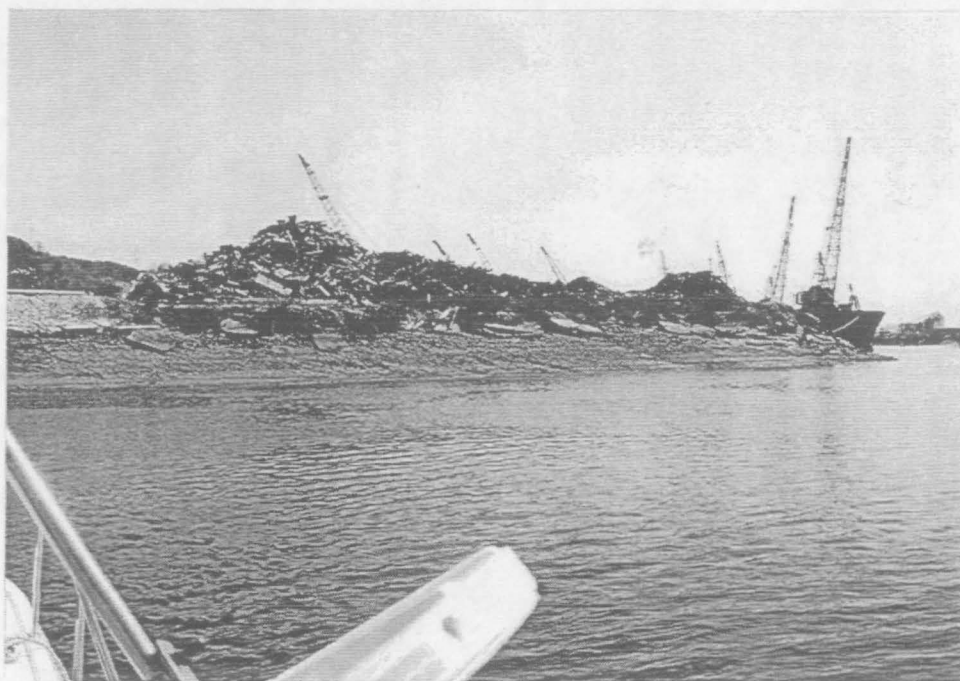
Photo was taken at an estimated tidal height of -1.2 feet

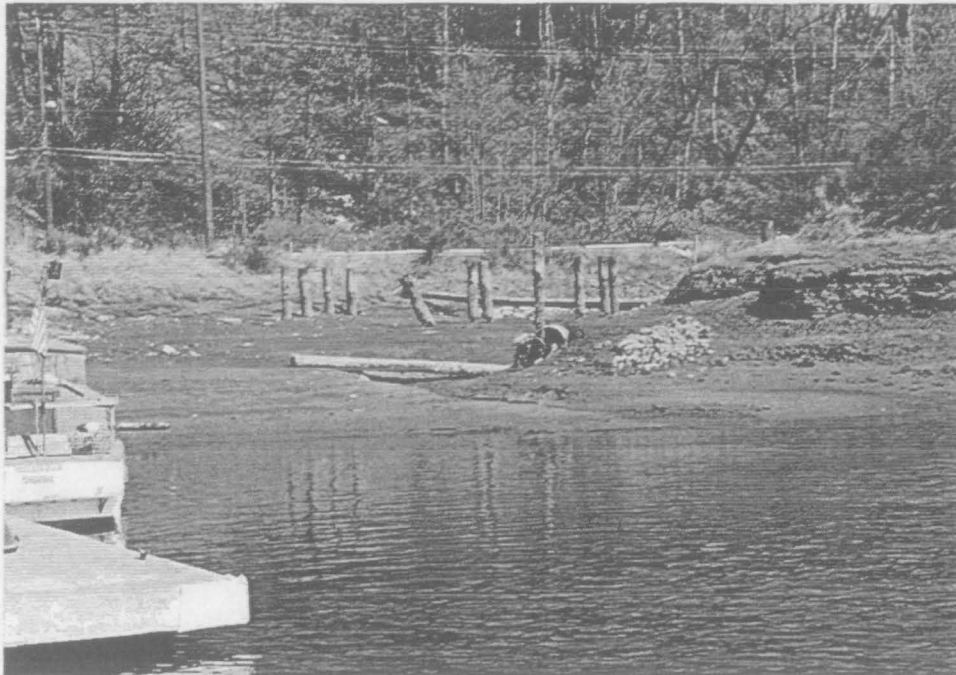
Photo was taken at an estimated tidal height of -1.2 feet

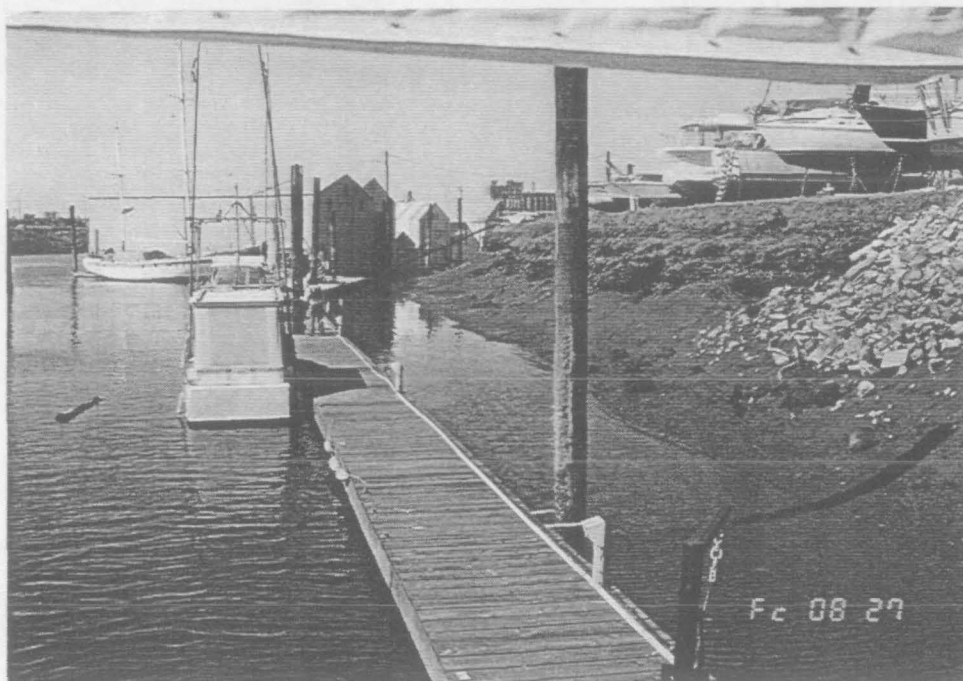
Photo was taken at an estimated tidal height of -1.0 foot

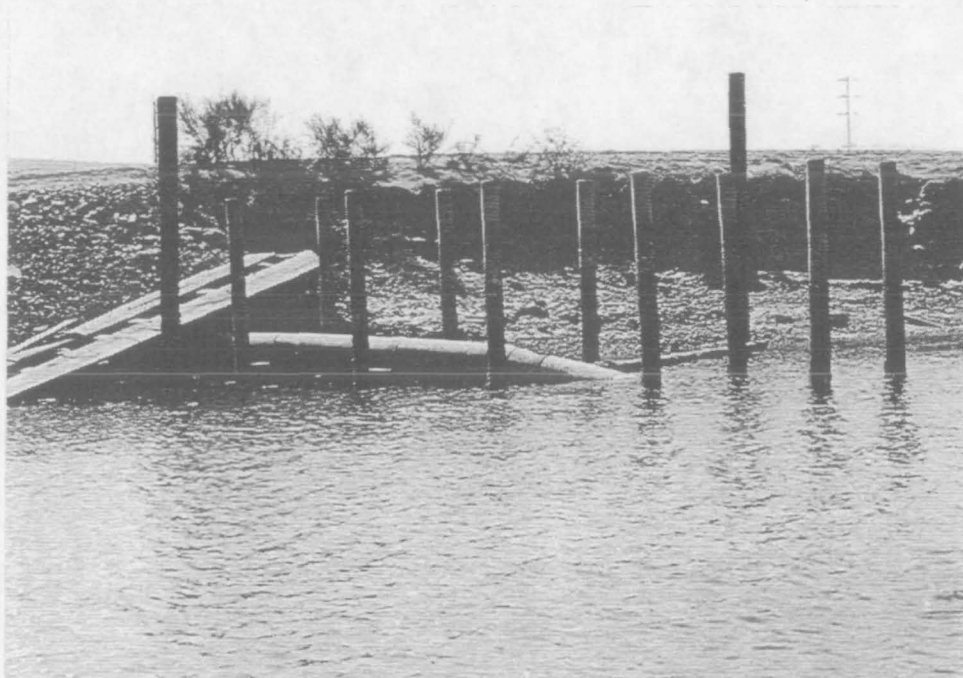
Photo was taken at an estimated tidal height of 0.8 foot

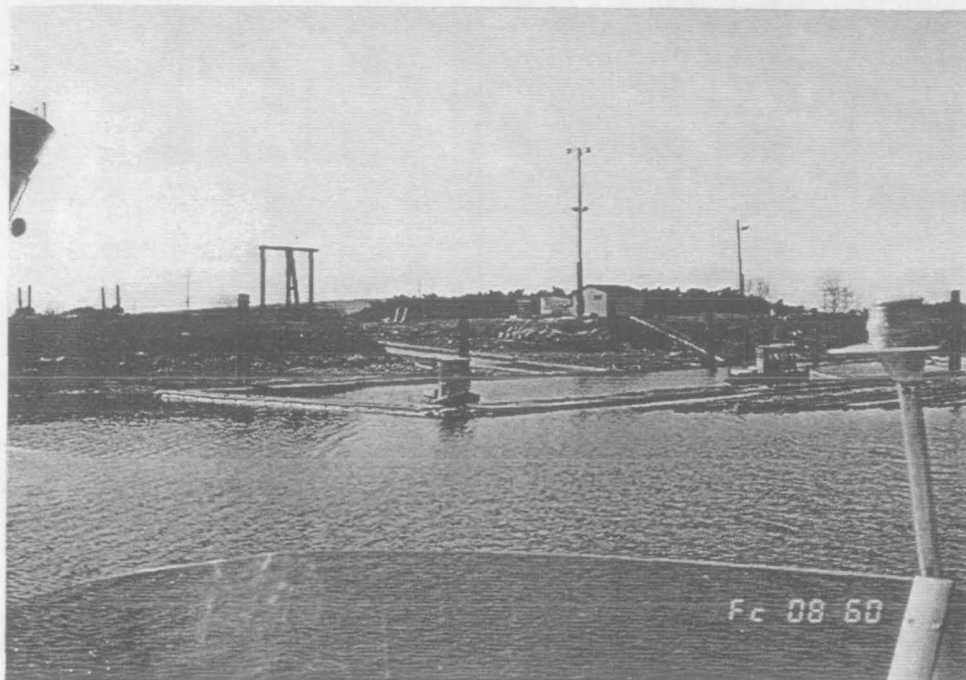
Photo was taken at an estimated tidal height of 0.6 foot

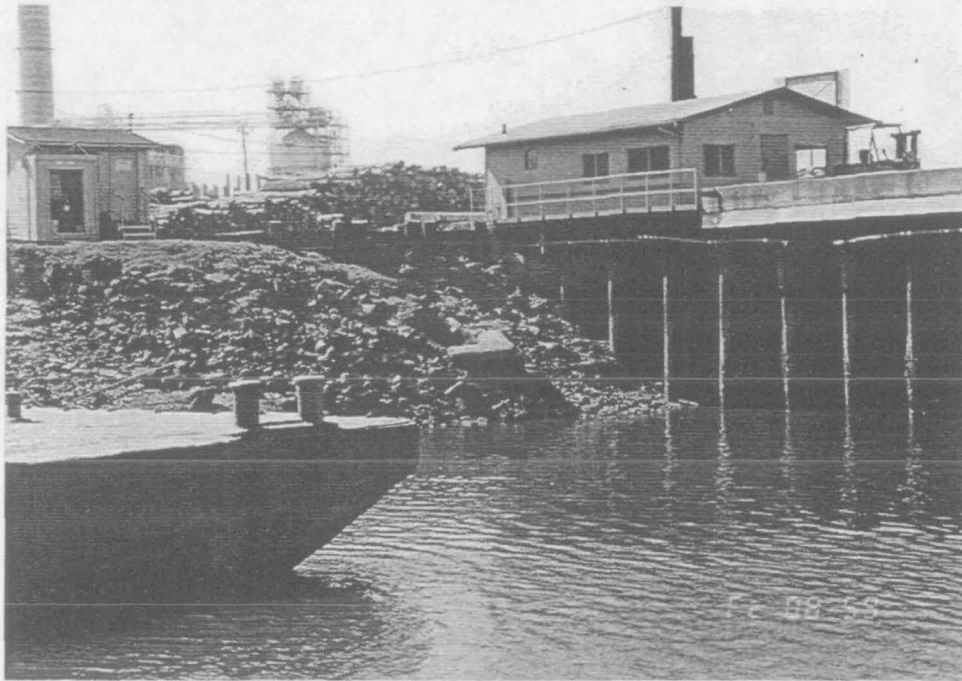
Photo was taken at an estimated tidal height of 0.3 foot

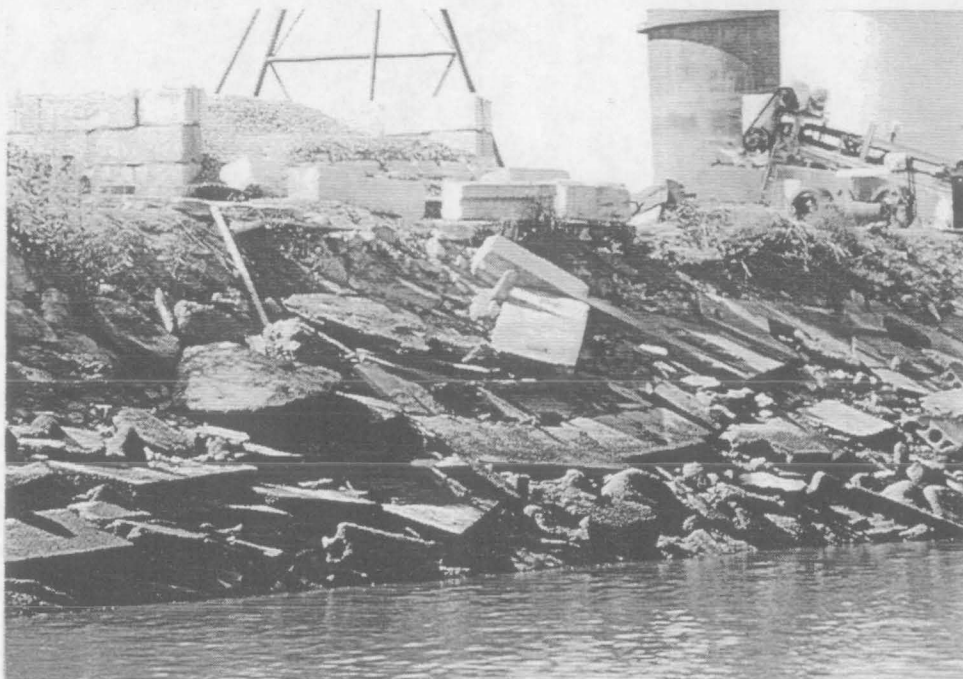
Photo was taken at an estimated tidal height of 0.1 foot

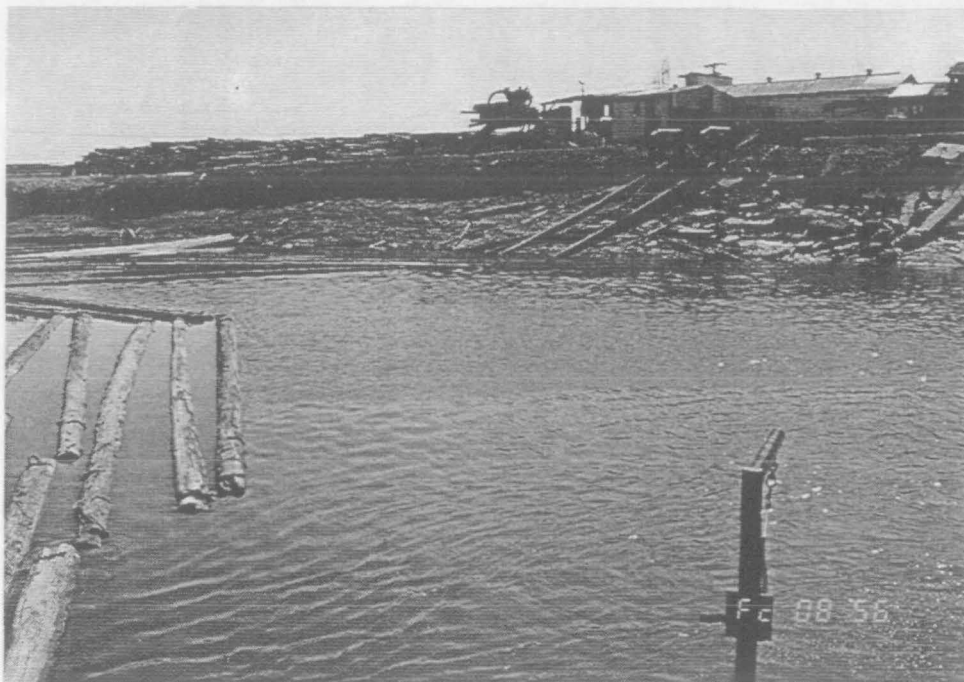
**Plate 65**

This sample is to be a potential source material sample. Its location will be determined at the time of sampling by the HCC and EPA.

Photo was taken at an estimated tidal height of 0.0 feet

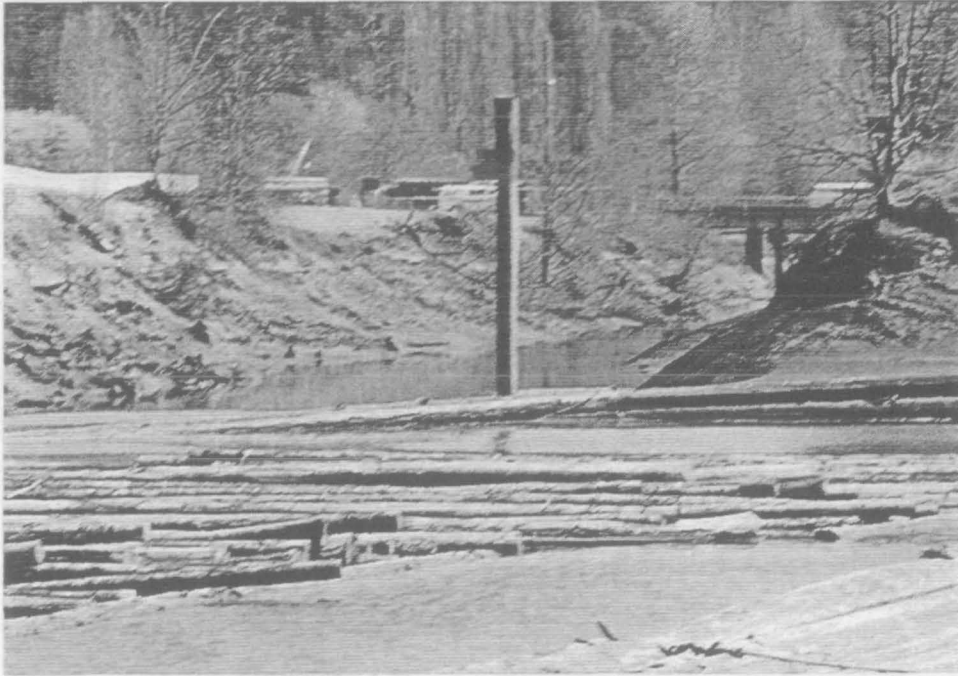
Photo was taken at an estimated tidal height of 0.0 feet

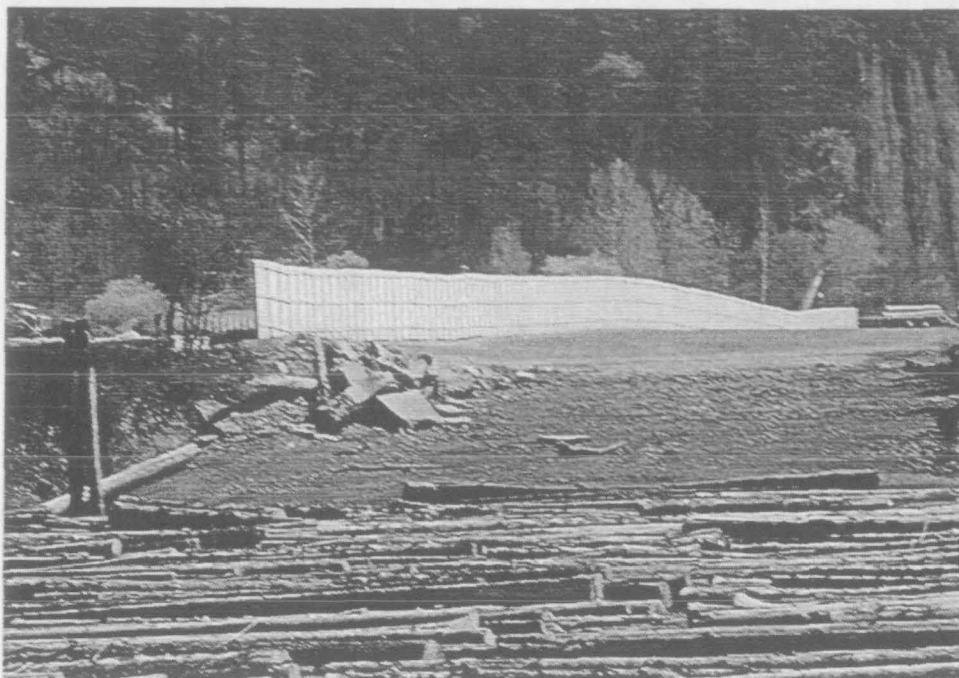
Photo was taken at an estimated tidal height of 0.0 feet

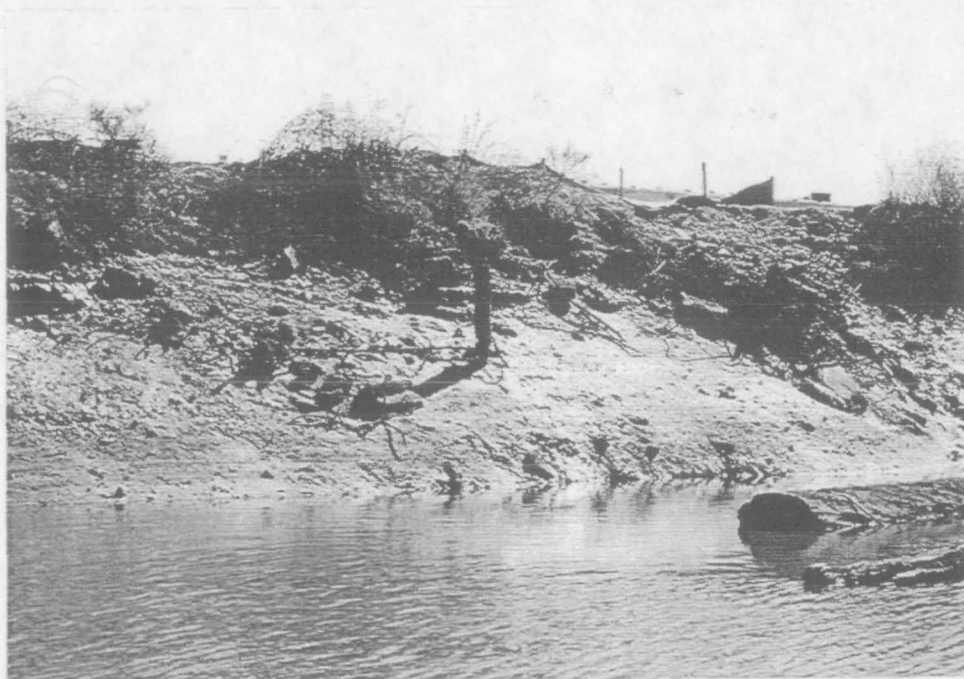
Photo was taken at an estimated tidal height of -0.1 foot
